ENERGY SOLUTIONS PLUS, LLC

ElectroFlow™ System Operation Report

Pepsi Beverages Company
Pepsi Honolulu

Project #: 41001
September 14, 2011

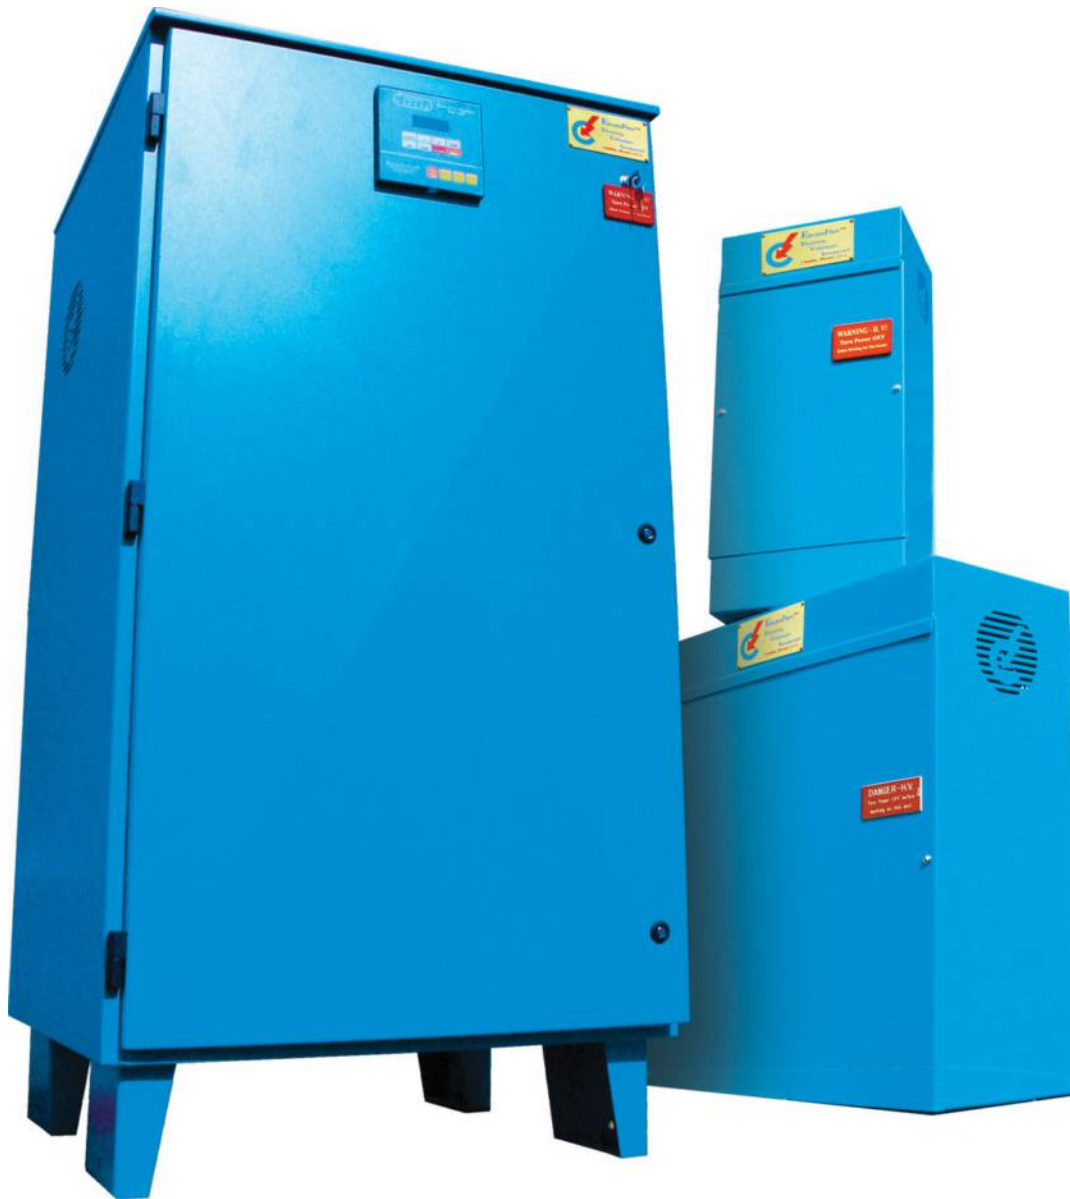
A total of eight ElectroFlow devices were installed at the bottling plant. Three on what is defined as the “new main” which provides power to the bottling lines. And five on what is defined as the “old main” which provides power to the ammonia compressors. Installation details and diagrams can be found in appendix B. The ElectroFlow units went live on 10/10/2010 and have been in operation since that date.

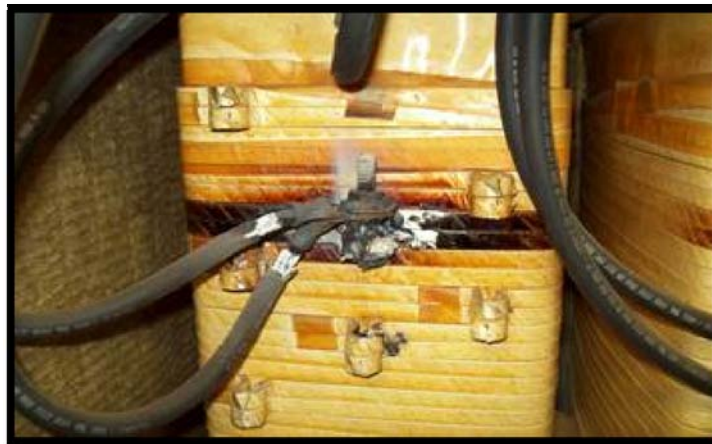
Burned Out Transformer Core

Since our first site visit we found that the 500kVA transformer's operating temperature was abnormal. We were told it has been this way as long as anyone can remember. The voltage was stable and the current was balanced.

When we energized this transformer after the ElectroFlow install, we saw an arc-flash from the bottom of the transformer. This was mentioned to your maintenance crew and suggested to have the transformer looked at by the manufacturer. We also wanted to see how our equipment would affect the temperature, which was 236 deg the day before installation. Post installation the transformer had dropped by 30 degrees. The transformer was also inspected on 11/5/2010 by an electrician and found to be within its normal operating limits. The complete electrician's report can be found in appendix F.

Last January the transformer failed on one of its three phases. Immediately upon failure the ElectroFlow unit was able to make up for 90% of the loss on that phase by pulling power from the other two phases. The voltage readings at the blow molder main, down line from the ElectroFlow equipment, were 400/400/382 (400 because of European equipment). Next the voltage was measured inside the transformer and before the ElectroFlow equipment with readings of 400/398/230. This is one of the amazing capabilities of ElectroFlow technology. The installation of the system likely averted an expensive failure in that area of the plant. The transformer core as it turned out had been faulty and a new transformer is now in place.

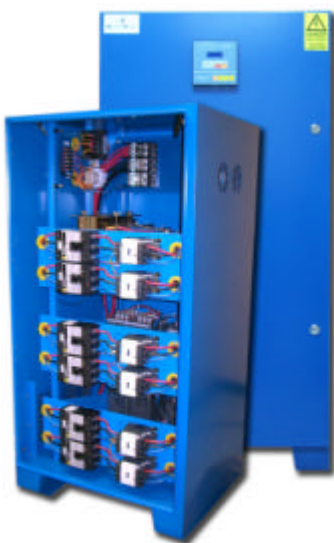
Figure1 : Automatic System

- Internal parts & components: L, R, C, regulator, protective devices, contactors, SDF, cabinet
- Hybrid Configuration: Main and sub main (Figure 2)
- Installation in parallel
- Passive system: Actively switched
- Harmonics filtering: IEEE 519 standards
- Surge & transients filtering: 50 000 V to 300 000 V
- Power Factor: From 90% to 100%

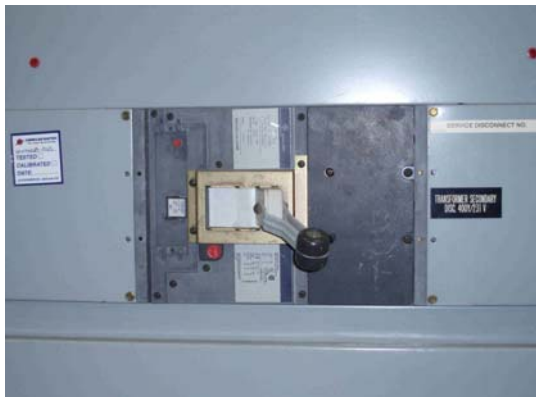
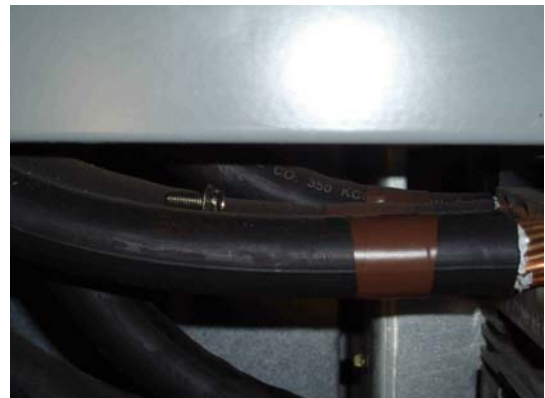
Electrical Inspection Report Sheet					
Customer		Location			
ETI		Pepsi Bottling Plant Halawa			
Date	Equipment Type		Technician	Report #	
11/05/2010	Transformer Secondary Main		Kent Fukuhara	1	
Specifications		Value		Unit	
Current Rating		800		Amps	
Voltage Rating		480		Volts	
Breaker Type		GE Spectra Series HI Break Cat.# SKHA36AT0800			
Severity Criteria					
Correct		Schedule to Correct		Critical to Correct	
-		-		-	
KVA	Horsepower	Current Rating	Current Draw	Voltage	Voltage Drop
NA	NA	800	156	401	NA
AIC	%Z	800	145	405	NA
50k	NA	800	145	404	NA
Problem Discription or Opinion					
The breaker was found to be in good condition with no apparent problems. Upon opening the front cover, there was a screw found to be laying on the phase A wires which could of caused an arc flash and short circuit.					
Recommendations For Repair					
The screw was removed for safety reasons.

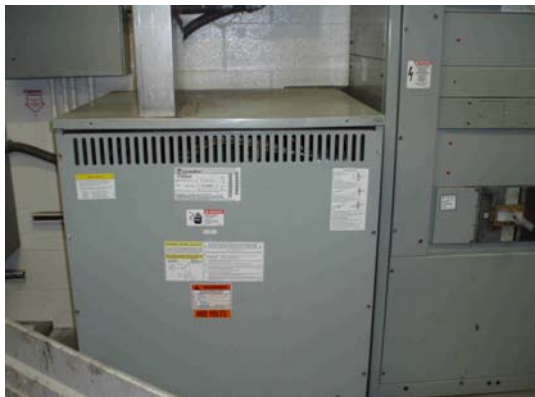
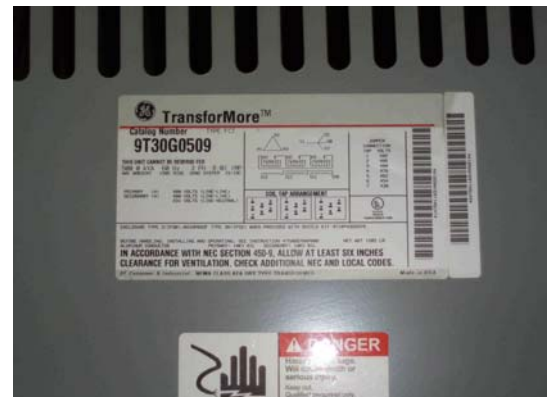
Electrical Inspection Report Sheet					
Customer		Location			
ETI		Pepsi Bottling Plant Halawa			
Date	Equipment Type	Technician	Report #		
11/05/2010	Transformer	Kent Fukuhara	1		
Specifications		Value		Unit	
Current Rating		600 / 800		Amps	
Voltage Rating		480v to 400v		Volts	
Transformer Type		GE Type FCT Cat. # 9T30G0509 TransforMore FAC			
Severity Criteria					
Correct		Schedule to Correct		Critical to Correct

-		-		-	
KVA	Temp Rise	Current Rating	Current Draw	Voltage	Voltage Rating
500	150	800	156	401	NA
AIC	%Z	800	145	405	NA
NA	8.0	800	145	404	NA
Problem Discription or Opinion					
This is the specialty transformer. It could not be opened due to critical process of equipment it is serving. This type of transformer does have a disconnect breaker built inside and is used as a part of a safety feature.					
Recommendations For Repair					
This type of transformer is a smaller design and is due to the addition of fans to cool the transformer as required.

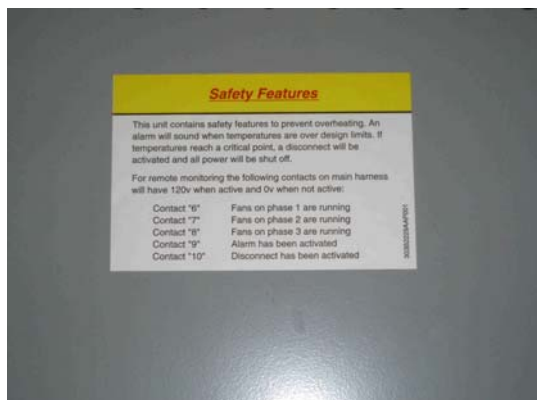
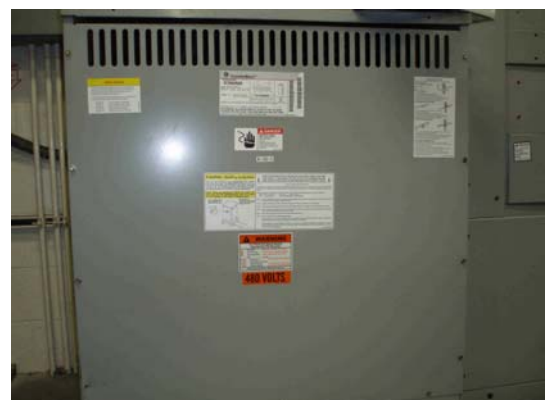
Electrical Inspection Report Sheet					
Customer		Location			
ETI		Pepsi Bottling Plant Halawa			
Date	Equipment Type	Technician	Report #		
11/05/2010	Transformer	Kent Fukuhara	1		
Specifications		Value		Unit	
Current Rating		600 / 800		Amps	
Voltage Rating		480v to 400v		Volts	
Transformer Type		GE Type FCT Cat. # 9T30G0509 TransforMore FAC			
Severity Criteria					
Correct		Schedule to Correct		Critical to Correct

-		-		-	
KVA	Temp Rise	Current Rating	Current Draw	Voltage	Voltage Rating
500	150	800	156	401	NA
AIC	%Z	800	145	405	NA
NA	8.0	800	145	404	NA
Problem Discription or Opinion					
The transformer does list a safety feature which will shut off the transformer if the temperature does reach a specified temperature limit.					
Recommendations For Repair					
There has been no reports from the facility electrician that the transformer has turned off. If it did, then they would have to open the front cover and reset the disconnect switch breaker.
